Manhole Inspection Summary

Manhole # S13II2003MH

Insp Date: **6/30/06 11:29 AM**

Location Address: **2110 SAREVA DR**

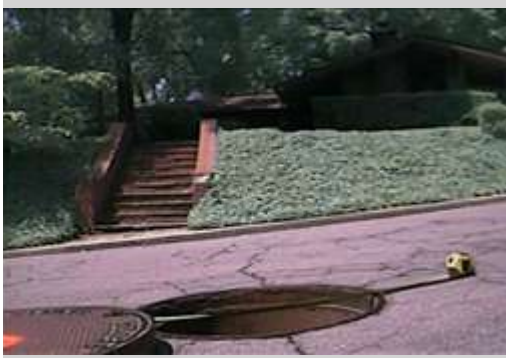
Location View

Comments **Cracks in pavement around manhole. Possible source of infiltration.**

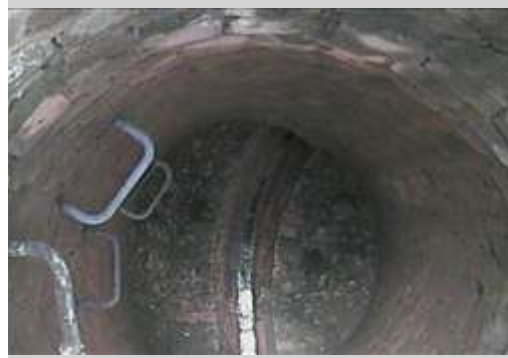
Top View

Bench debris.

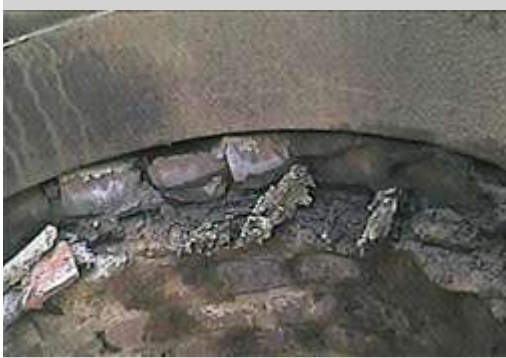
Defect

Frame Offset: **3** (in.) Condition: ☐ Sound ☐ Cracked ☒ **Leaks**

Condition: ☐ Sound ☐ Cracked ☐ Root Intrusion ☒ **Loose Brick** ☒ **Deteriorated**

Infiltration: ☐ None ☒ **Joint** ☐ Cracks ☒ **Mortar** ☐ Roots ☐ Wall

Frame leaks. Adjustment deterioration, loose brick, and infiltration.

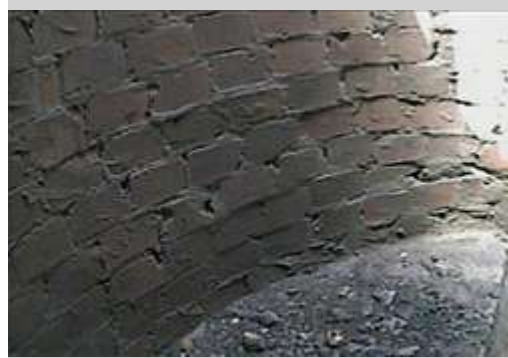
Defect

Condition: ☐ Sound ☐ Cracked ☐ Root Intrusion ☐ Loose Brick ☒ **Deteriorated**

Infiltration: ☐ None ☐ Joint ☐ Cracks ☒ **Mortar** ☐ Roots ☒ **Wall**

Barrel deterioration and infiltration.
